VARN **Kompac**[®]

TECHNICAL and SERVICE BULLETIN

No. 11

GRAPH TECH TAKES THE BOUNCE OUT

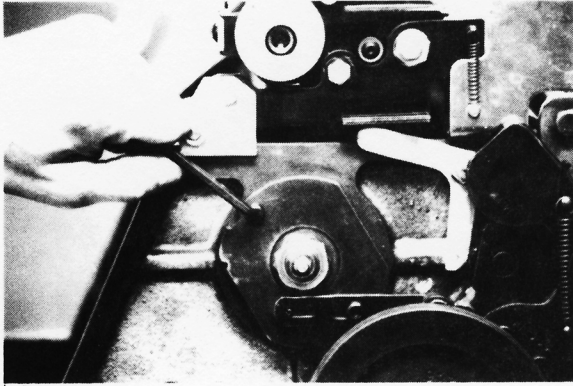
Fig. 1

5. Check that the impression cylinder latch lever is not on "impression". This will insure the plate cylinder is at its highest position.
6. Remove Allen head screw from the non-operator side to allow easier access to first lock nut. (Fig. 1)

10. Reinstall Allen head screw. (Fig. 1)
