TECHNICAL AND SERVICE BULLETIN

NO: 36

DATE: OCTOBER 1991

TO: ALL KOMPAC DEALERS
SUBJECT: SEAL BURN IN

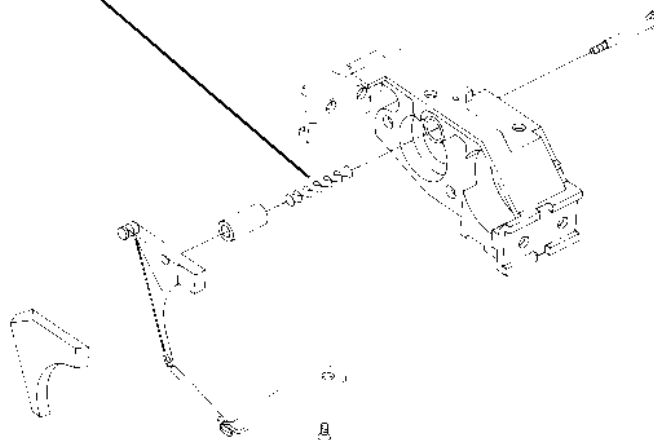
The lightweight springs may be identified by their silver color as opposed to the heavy, bronze colored springs.

92238

Compression Spring

If seals not seating properly is a continuing problem, please call Graph Tech Customer Service (1-800-541-5702) for replacement springs, free of charge. Labor, however, will not be credited.
